PERFORMANCE EVALUATION OF EXISTING BUILDINGS IN THE AUGUST 24, 2016 CENTRAL ITALY EARTHQUAKE

MARIA HELENA PAIXÃO COSTA

Dissertação submetida para satisfação parcial dos requisitos do grau de
MESTRE EM ENGENHARIA CIVIL — ESPECIALIZAÇÃO EM ESTRUTURAS

JUNHO DE 2017

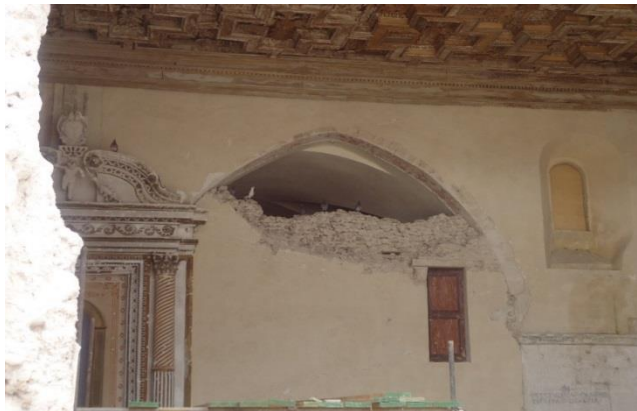
The next figure is an example of incorrect closure of an opening in a church located in Norcia uncovered during the 30th October earthquake. This large opening had been hidden for decades. In this case, the connection between the stone arch and the masonry was difficult to achieve.

Figure 5.18- Church in Norcia with uncovered opening due to dynamic loads

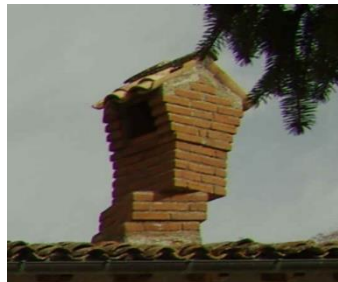
Pounding is also evident between the lower building and its adjacent. The chimney suffered rotation and sliding, figure 5.19.

Figure 5.19-Damage to non-structural element

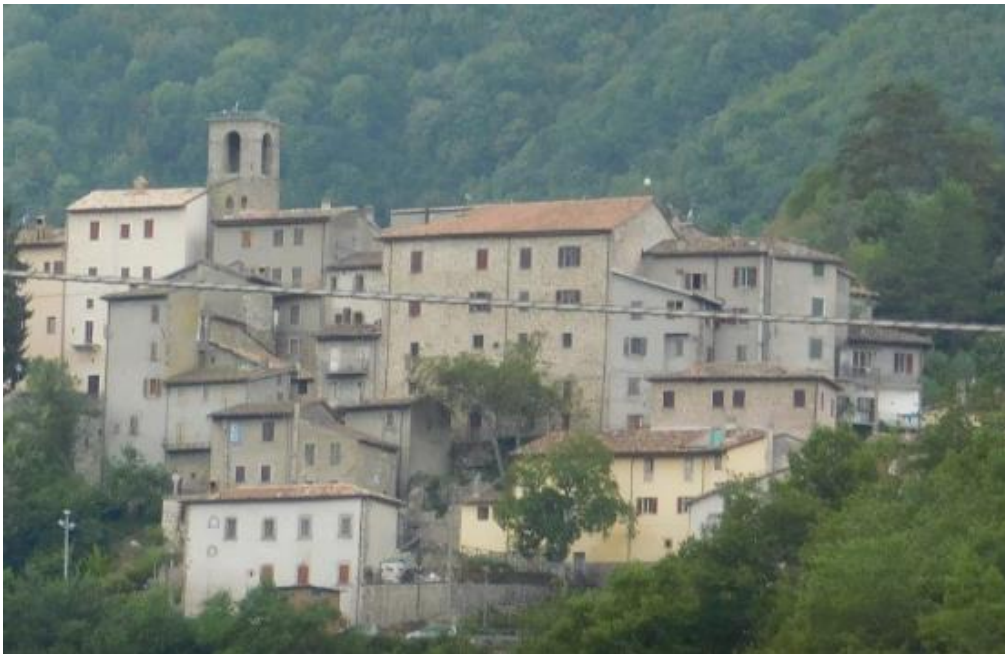
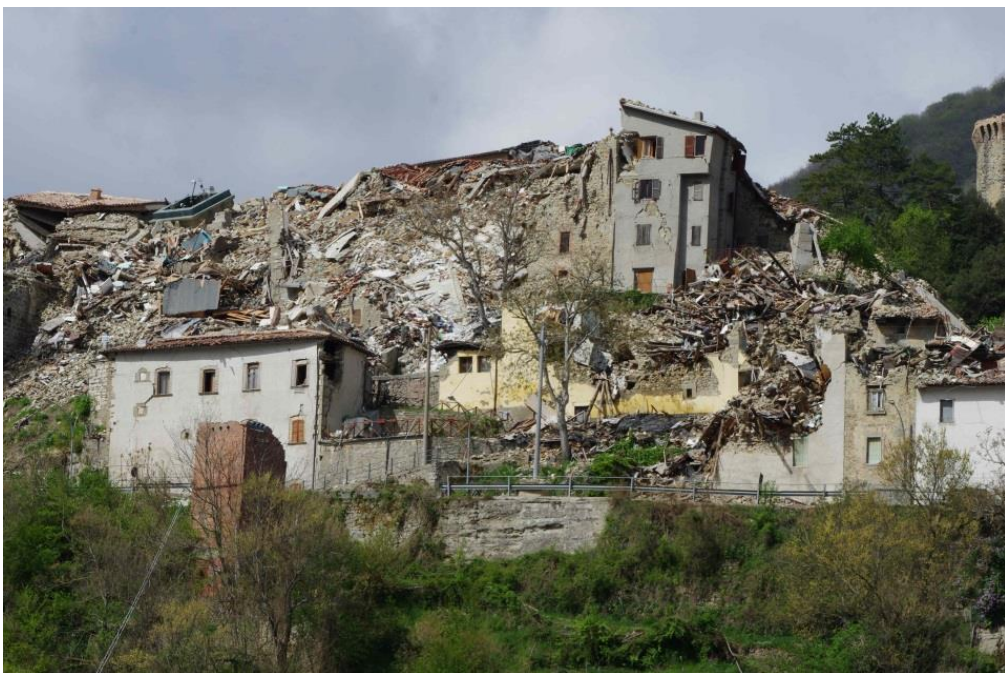
c)

Photo taken from the road, showing the total destruction of the village.

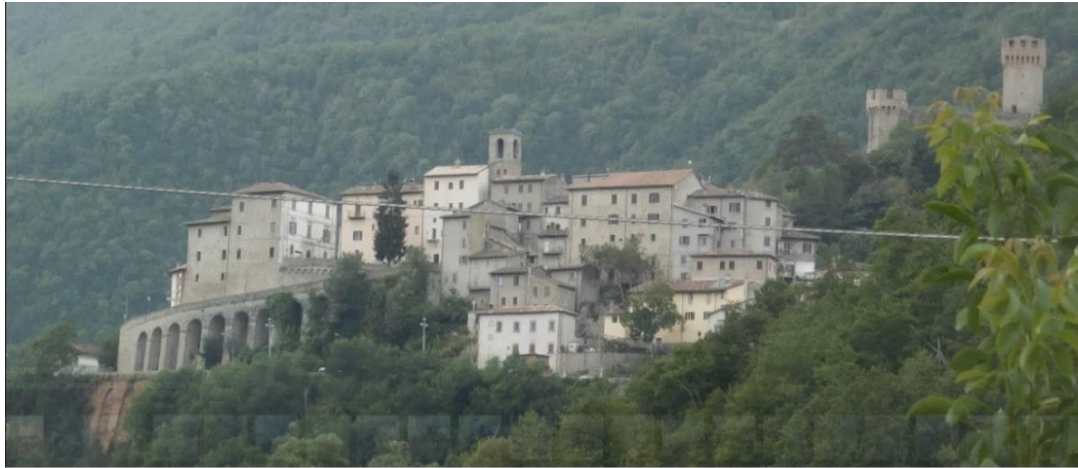
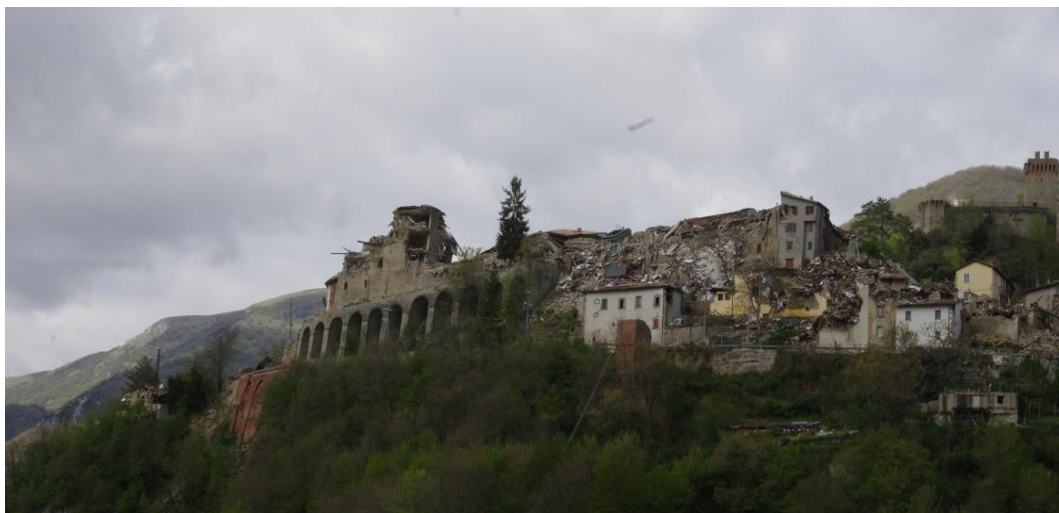
d)

Panoramic view showing the full destruction of Arquata del Tronto.

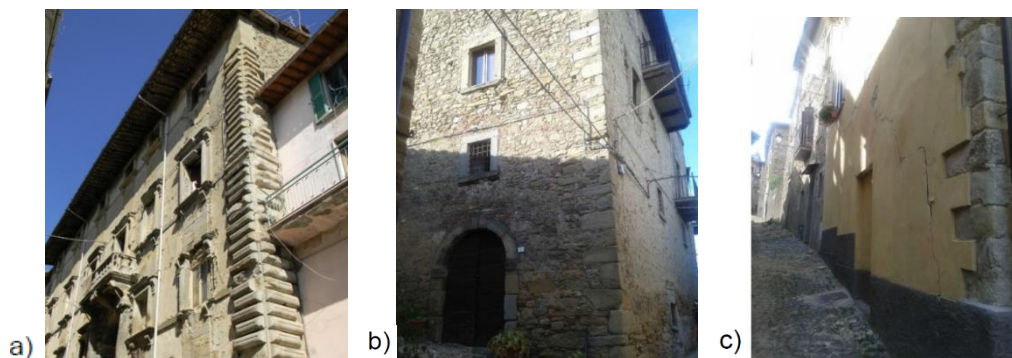
Figure 6.2-Insertion of quoins in the corners of buildings, Amatrice. The picture c) also demonstrates lack of quality of the masonry, as it is visible the stair stepped path in the wall

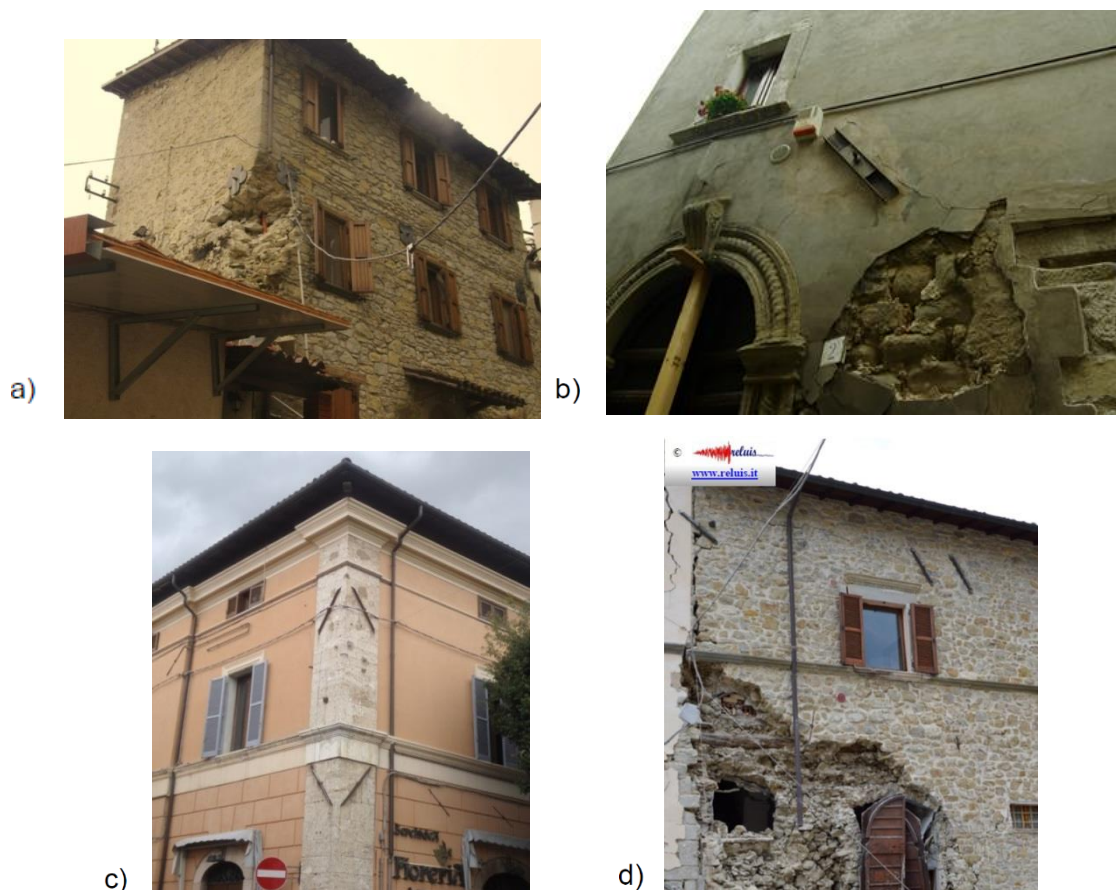
Figure 6.7 exhibits buildings representative of good performances, with tie rods. In case a), the existence of the reinforcement element possibly stopped the corner disaggregation, developed due to the poor quality of the masonry. In case b), the tie rod seems to have prevented the expansion of diagonal cracks and maybe also have avoided the out of plane failure of the plaster. The others do not show any damage. In figure d) the tie rods seem to have avoided the out of plane mechanism.

Figure 6.7-Good performance of tie rods,a) Pescara del Tronto, b) and d) Arquata del Tronto, c) Norcia

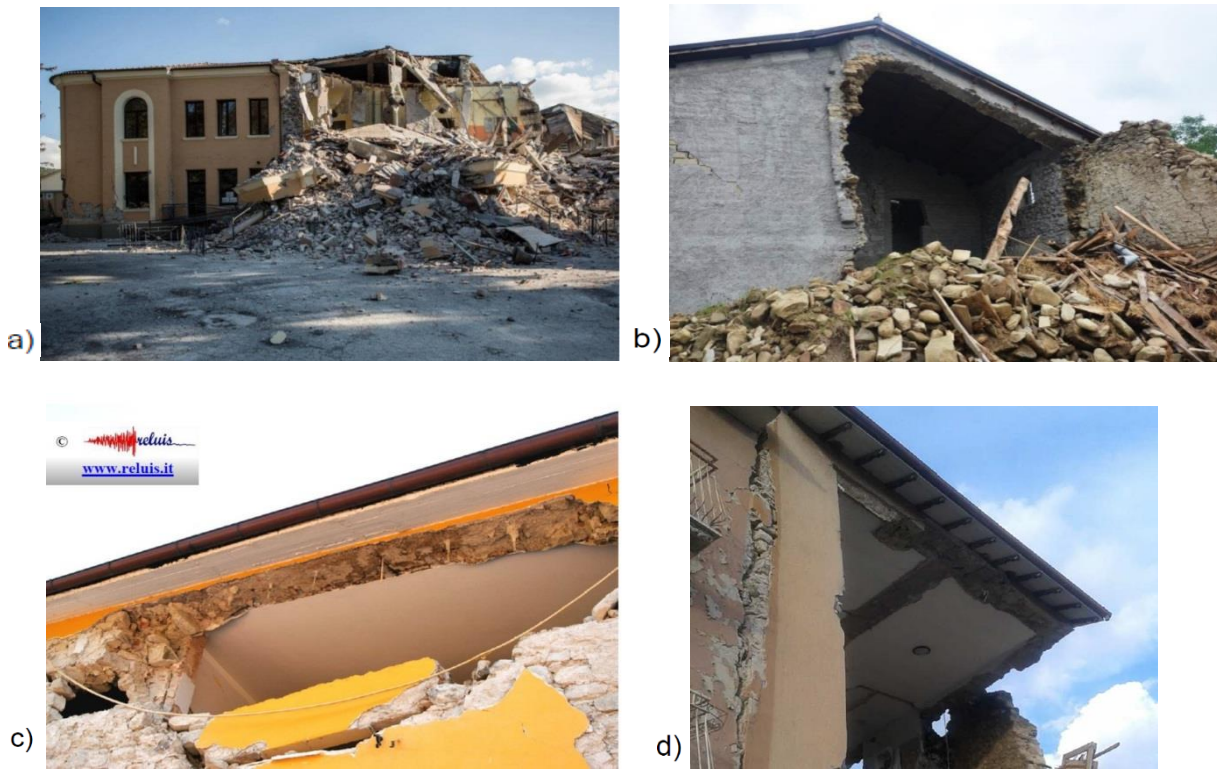
However, it is hopeless to introduce retrofit instruments if the masonry quality is still very poor and incapable of resist the earthquake action, which occurred in many cases in the affected area and figure 6.11 shows some examples. In case c) it is visible the anchors, probably due to a bad connection between the reinforced concrete ring beam and the poor quality masonry wall.

Figure 6.11-Interaction between reinforced ring beams in poor quality masonry, Amatrice

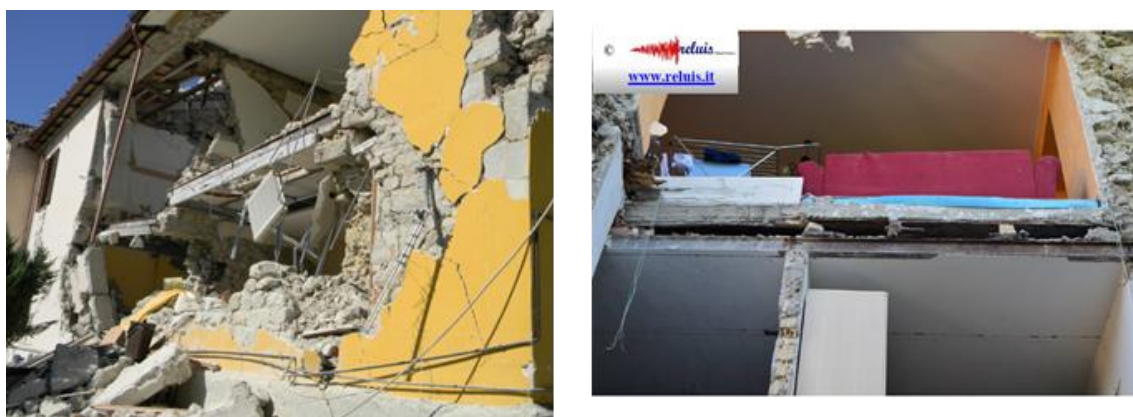
In other situations, the ring beams were introduced at the floors level, figure 6.12. The ideal situation would be to have both roof ring beam and floor ring beam in the structure but, at the time of the construction of Amatrice and nearby villages, this practise was not applied. The problem of picture b) is the bad positioning of the steel ring beam within the masonry wall. If the steel ring beam is not all in contact with the masonry wall its action is limited and the out of plane mechanism is allowed. In figure a) the steel ring beam also seems in a bad positioning within the wall, and it cracked due to the shear interaction with the partition wall.

Figure 6.12 -Bad positioning of steel ring beams at the floors level, Accumoli

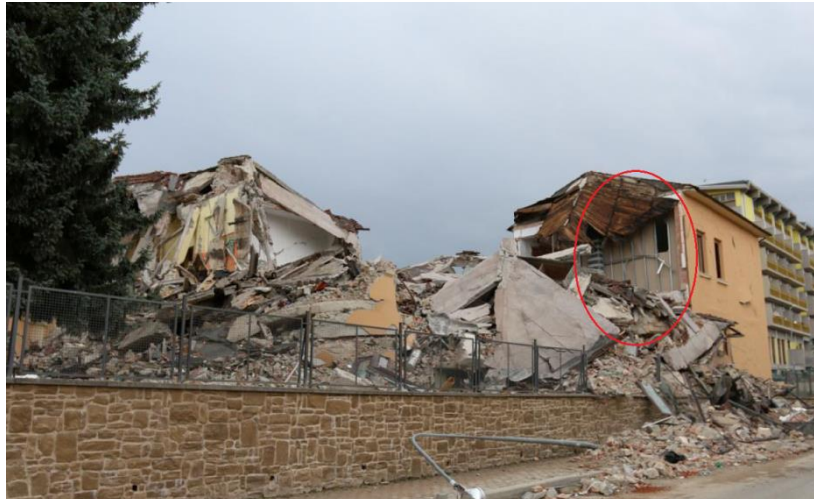
The following figures present the school Romolo Capranica in Amatrice. More than 700000 euros were spent on the improvement of the school and one the measures was the introduction of the seismic joint. Despite this reinforcement, 5 years after the school collapsed. As mentioned before, this building was constituted by blocks of masonry and blocks of reinforced concrete, figure 6.14. The seismic joint in figure 6.13 avoided the collapse of the reinforced concrete part but allowed the failure of the masonry block. This could be explained based on the poor masonry quality and poor constructions techniques, similarly to the majority of the old masonry in the region.

Figure 6.13 - Collapse of the masonry block and visible seismic joint, school of Amatrice

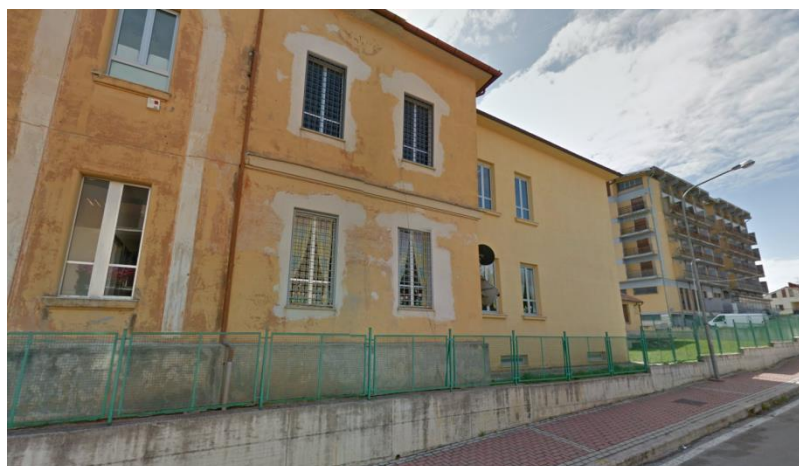
Figure 6.14- Pre-event image where the two different blocks are well recognisable (masonry and reinforced concrete blocks)
